Your Property Inspection Report

Sample Report, Orlando, FL 32819
Inspection prepared for: Sample Report
Real Estate Agent: Jay Huberty - Regal Real Estate Professionals

Date of Inspection: 10/9/2012 Time: 2:00 PM
Age of Home: 5 years Size: 5,779 SF
Weather: Partly Cloudy

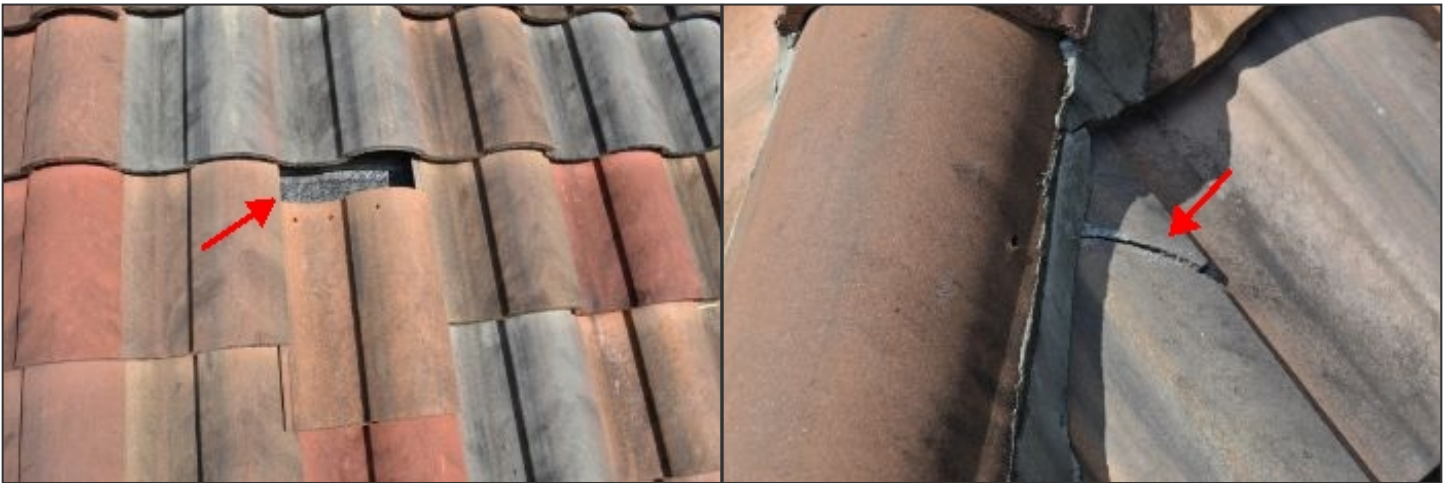
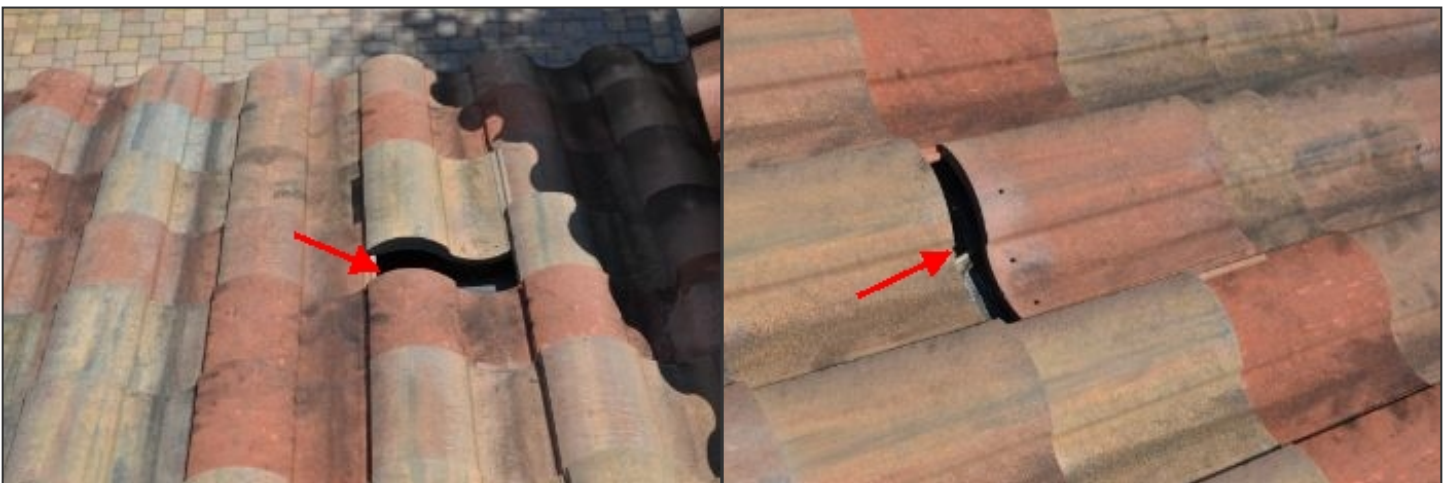
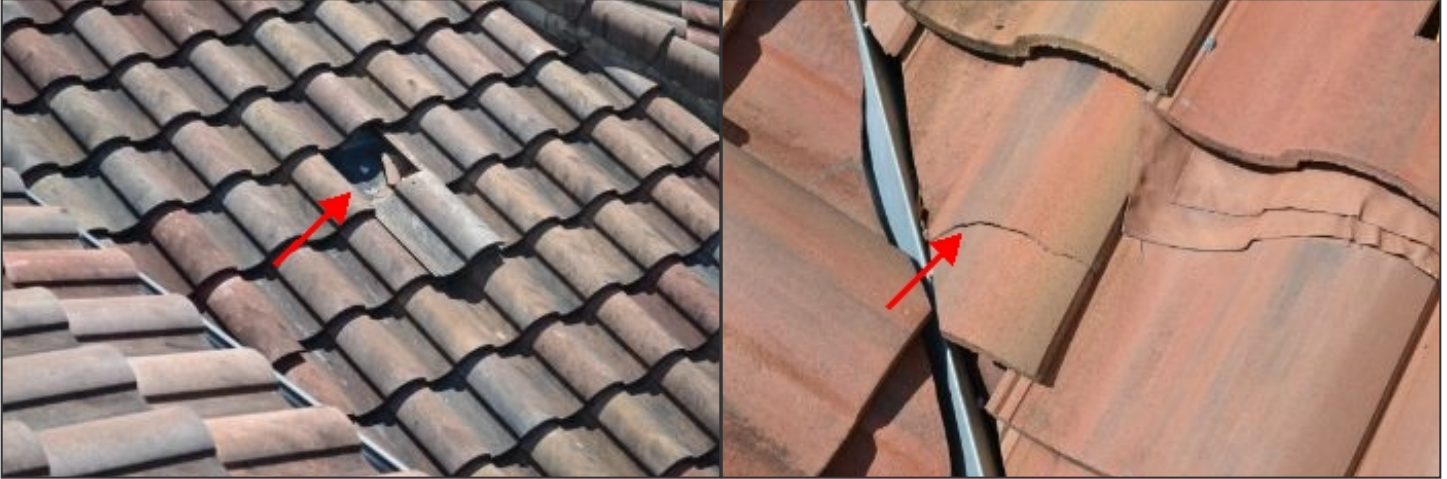
C.1. The roof had cracked or broken concrete roof tiles which should be replaced to prevent damage to the underlying roof structure from moisture intrusion.

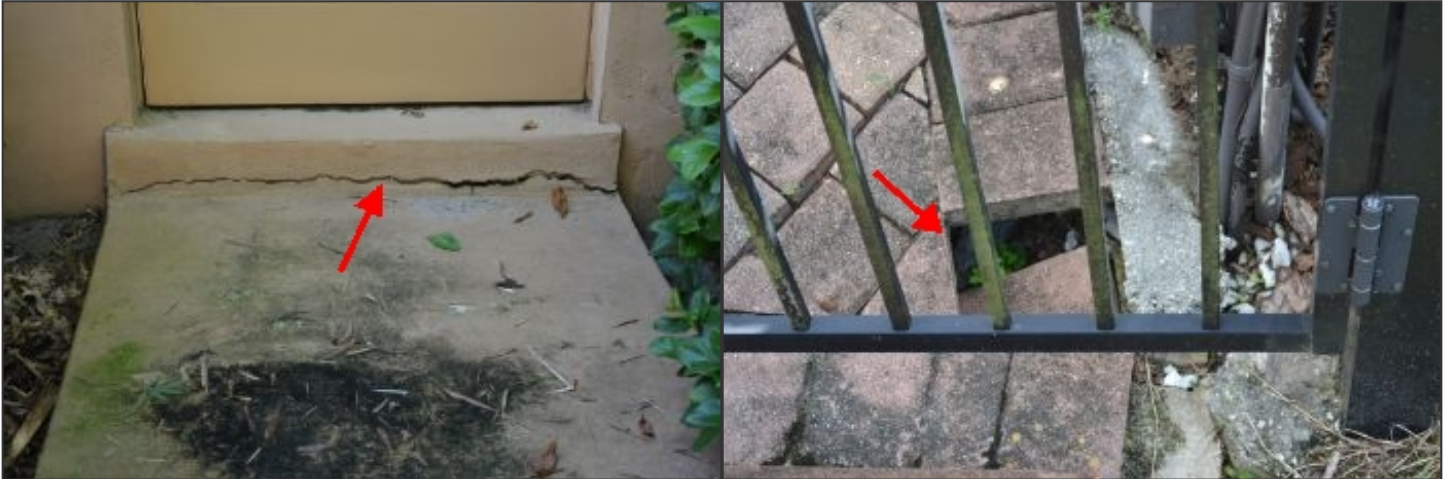
C.1. Significant crack visible outside garage door at the time of the inspection and should be patched with an appropriate sealant to avoid continued damage to the surfaces from moisture and development of trip hazards.

C.2. At the time of the inspection, the walkway located at the rear side of the home had settling visible indicating soil movement. This condition is typically the result of poor compaction practices during original construction. Settled areas are a trip hazard.

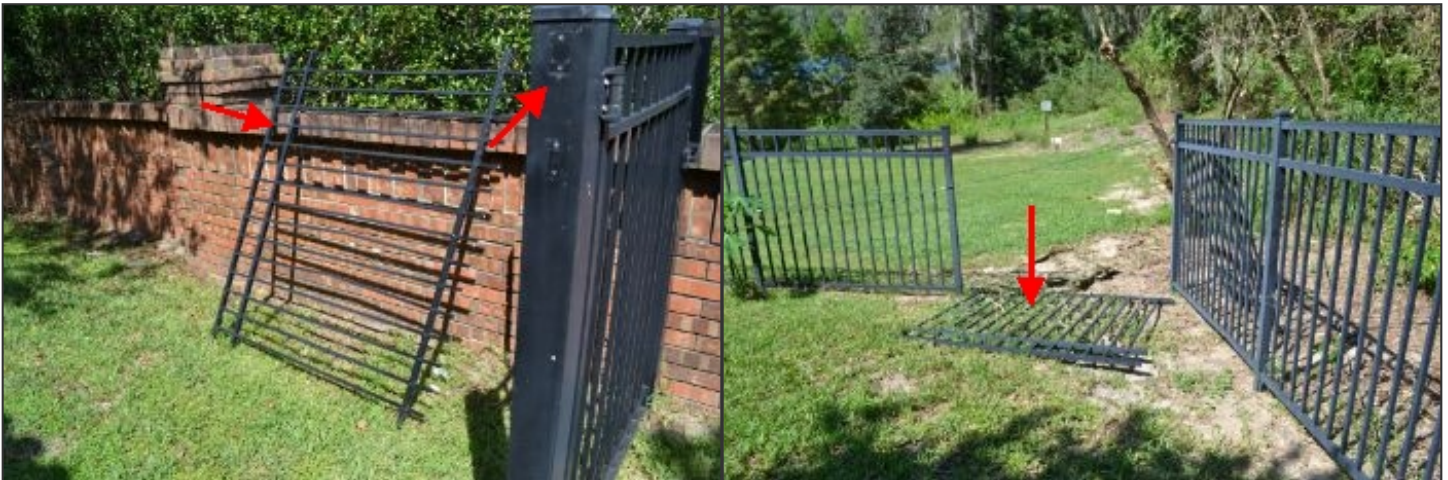
E.2. Damaged fence was visible at the right side of the home.

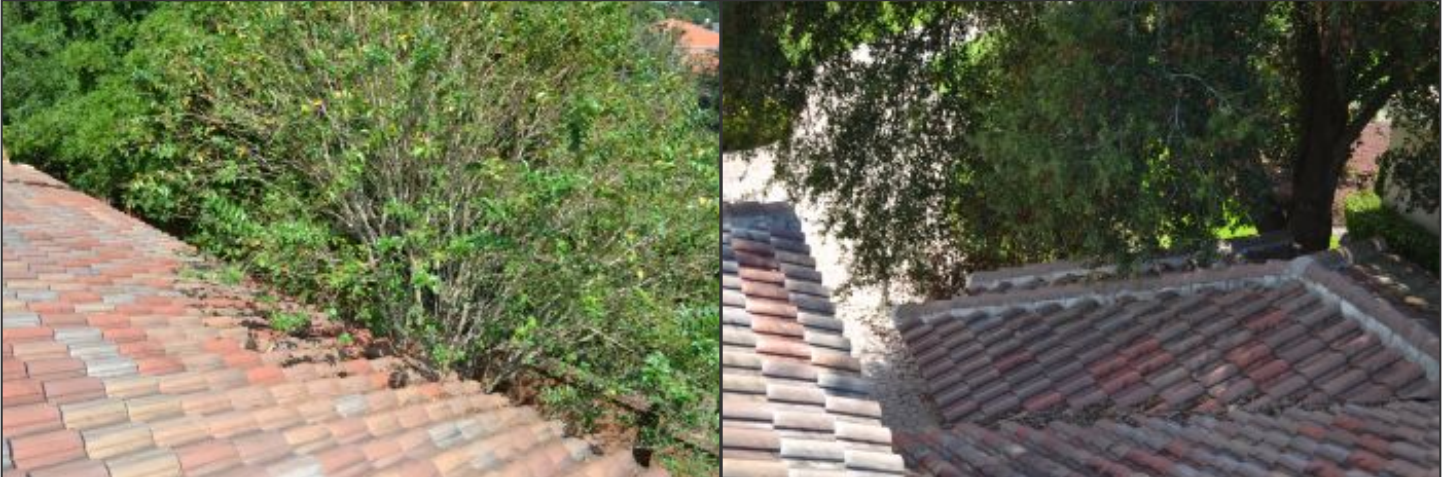
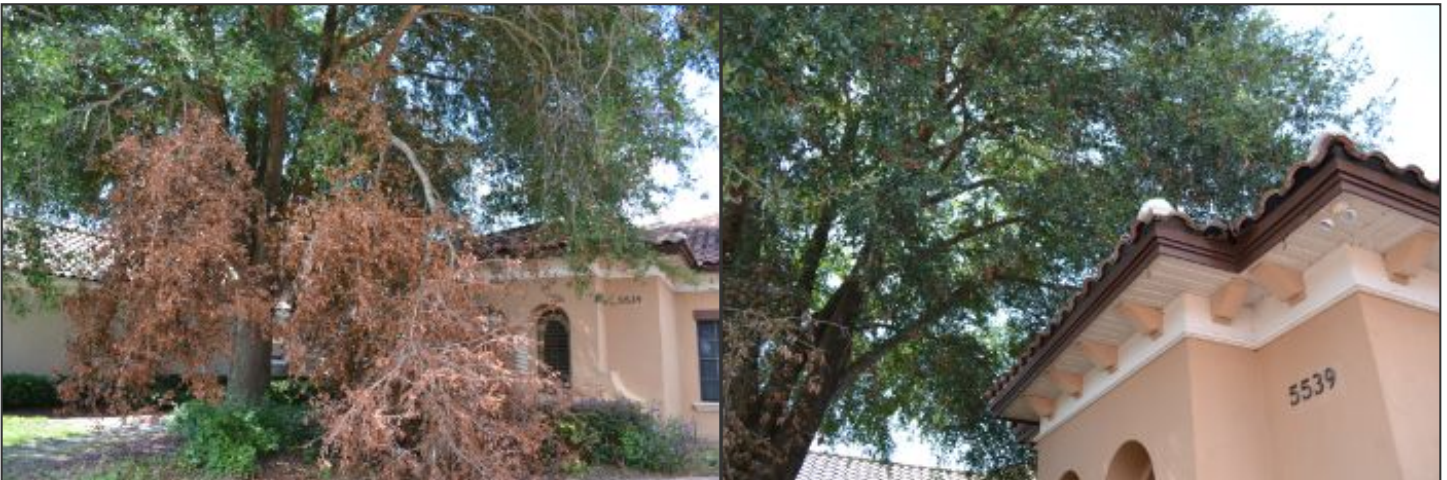
M.3. Large trees on the property had dead limbs. Falling branches due to conditions such as wood decay or high winds, may cause injury, death or damage. Evaluating trees lies beyond the scope of the general Home Inspection. Consider having these trees evaluated by a qualified arborist.

M.2. Tree limbs within 10 feet of roof should be trimmed away to provide air and sunlight to roof, while minimizing debris & dampness.

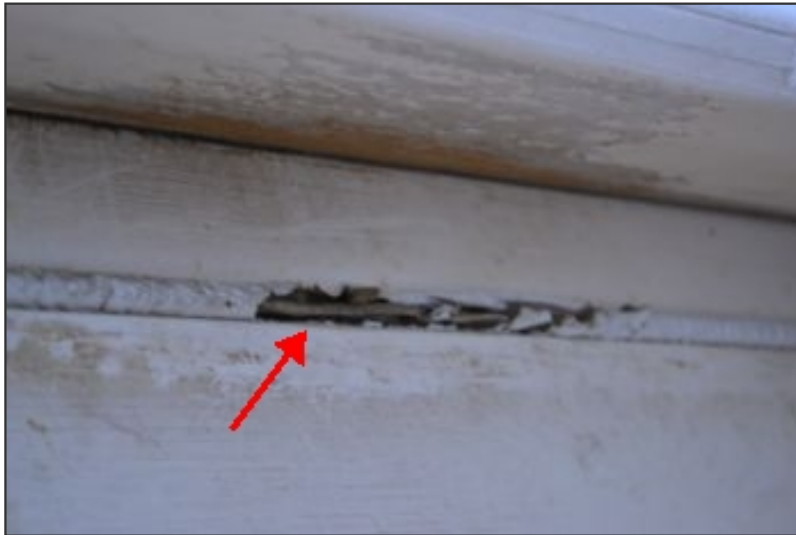
- J.1. The door between the living space and the garage failed to close by itself. Modern safety requirements require that the door between the home interior and the garage be self-closing for safety reasons related to fire hazard and toxic fumes. The Inspector recommends correction of this condition by a qualified contractor.
- J.2. *At the time of the inspection, weather-stripping at garage fire door was damaged or deteriorated and should be replaced to help prevent air/heat leakage which will increase heating/cooling costs and reduce home comfort.*

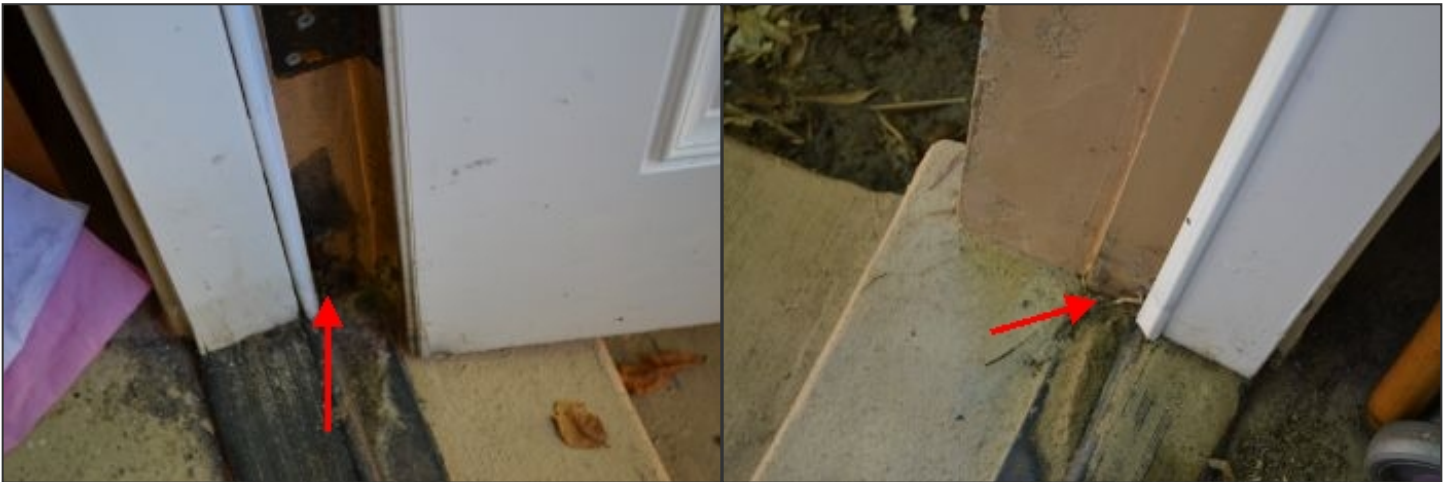
K.2. Wood decay was observed at the bottom of door frame.

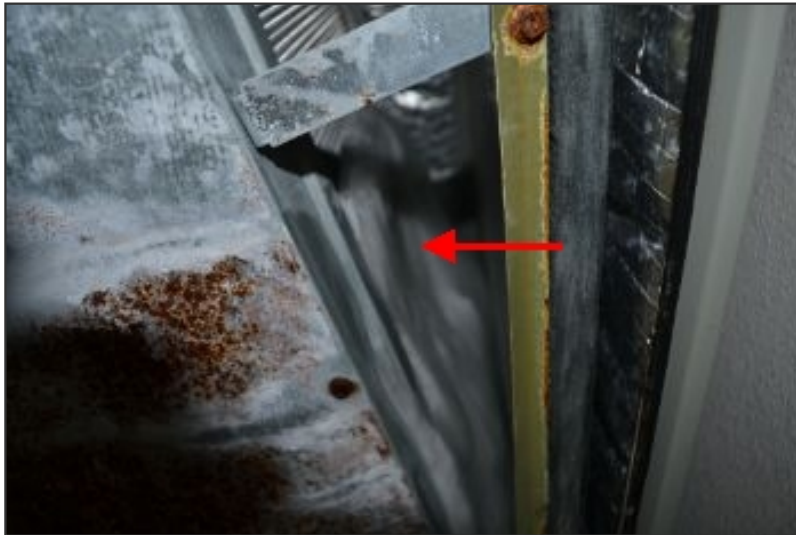
- B.1. The furnaces cabinet exterior appeared to be in serviceable condition at the time of the inspection.
- B.2. The estimated life expectancy of this unit is approx. 11 years. Average life of an forced air electric heat pump is approx. 16 years.
- B.3. Air handler heated supply air temperature: 101.5 degrees F
- B.4. This indicates the heating system is heating as intended.
- B.5. Unit #2 was getting frozen at the time of inspection. The Inspector recommends service by a licensed HVAC technician.

Unit #2 (Ice noted)

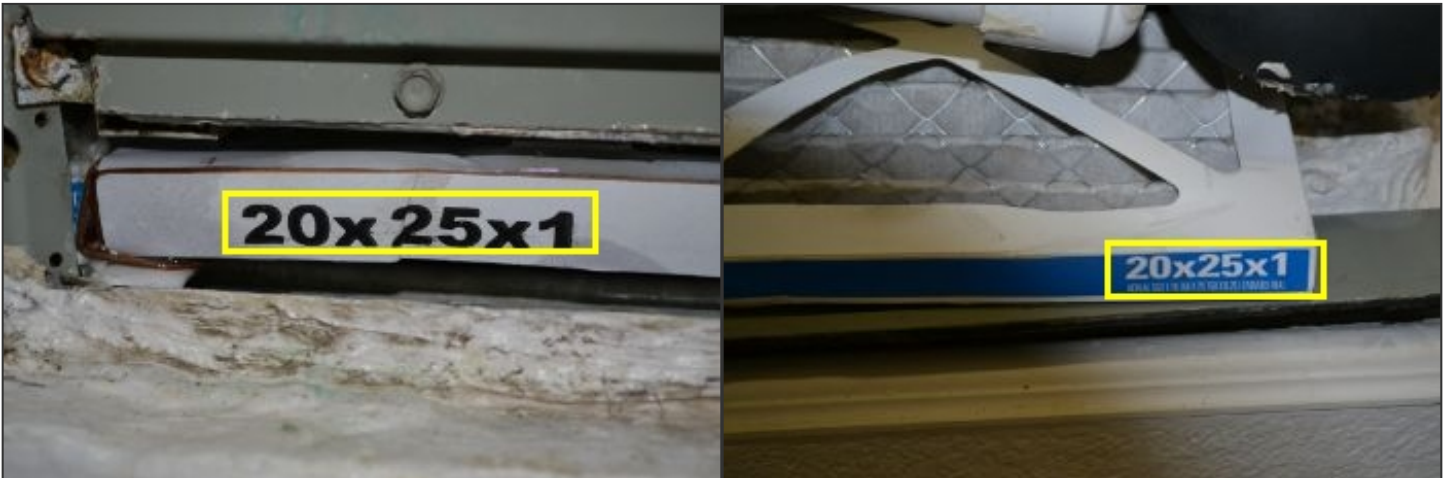
C.1. The furnace air filter was dirty and should be changed. Filters should be checked every month and replaced as necessary. Homes in areas with high indoor levels of airborne pollen or dust may need to have air filters checked and changed more frequently. Failure to change the filter when needed may result in the following problems: reduced blower life due to dirt build-up on vanes, which increasing operating costs, reduced effectiveness of air filtration resulting in deterioration of indoor air quality, increased resistance resulting in the filter being sucked into the blower. This condition can be a potential fire hazard, frost build-up on air-conditioner evaporator coils, resulting in reduced cooling efficiency and possible damage, and reduced air flow through the home.

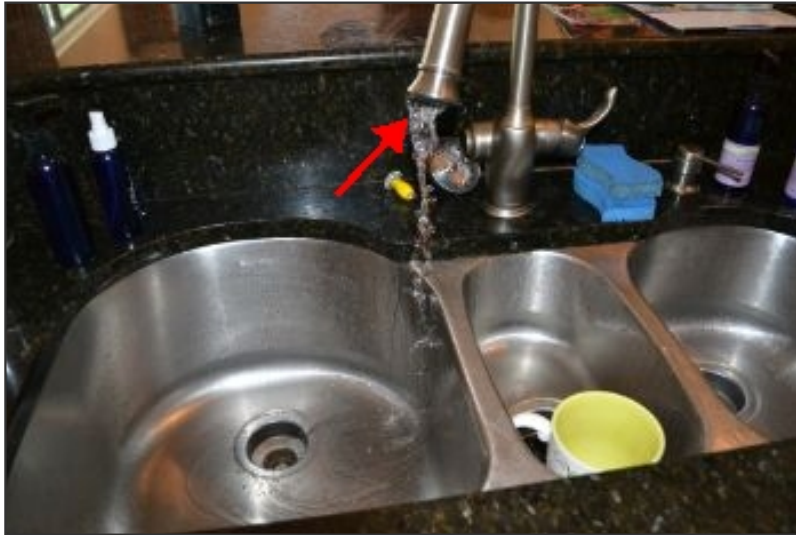
E.2. The main kitchen faucet was not working properly at the time of the inspection.

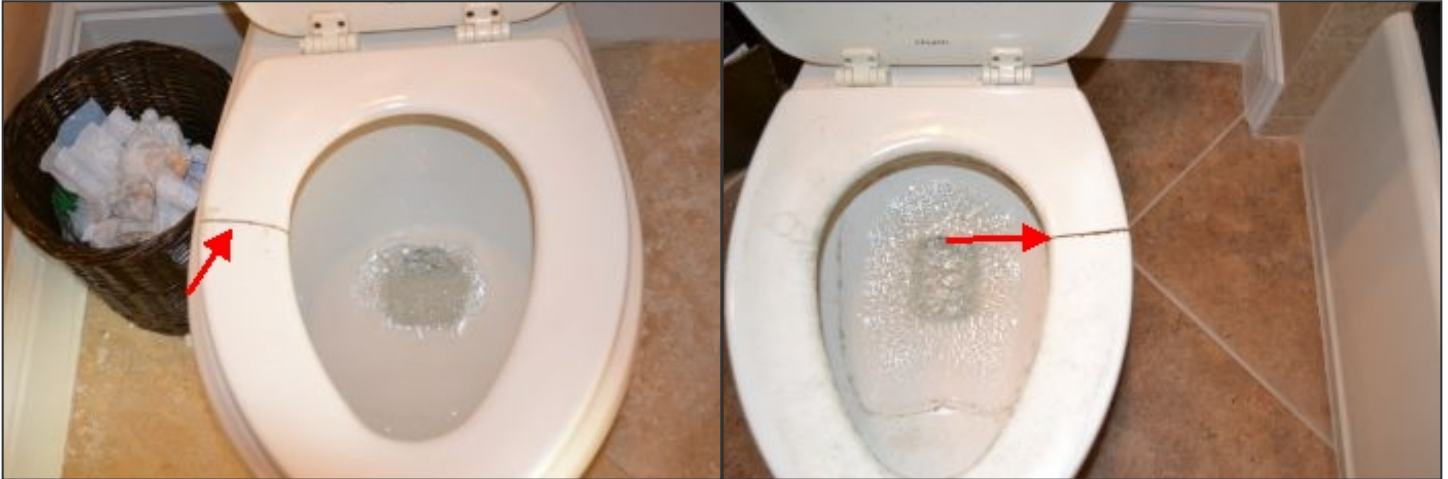
- E.1. *The toilet seat was damaged in some of the bathrooms.*

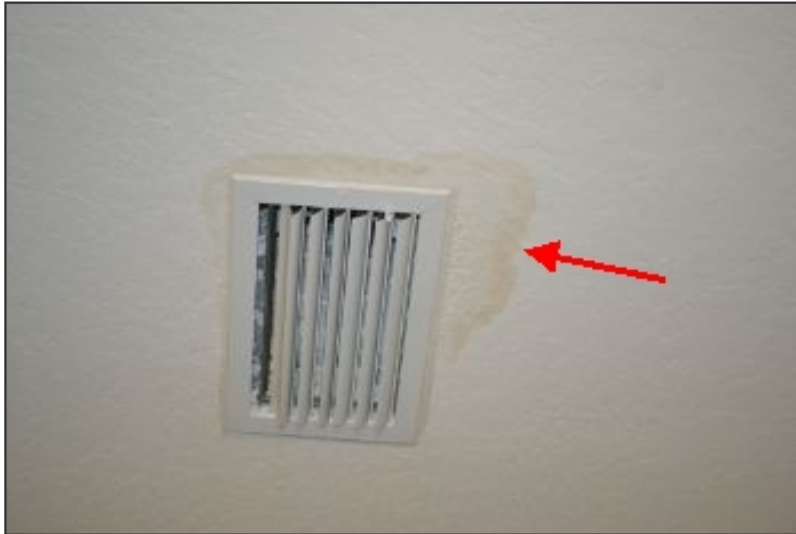
Bedroom #2

D.2. Stain in bedroom #2 visible at the time of the inspection appeared to be the result of moisture intrusion from air duct. The moisture meter showed no elevated moisture levels in the affected areas at the time of the inspection. Although this condition indicated that the source of moisture may have been corrected, testing would be required to provide confirmation.

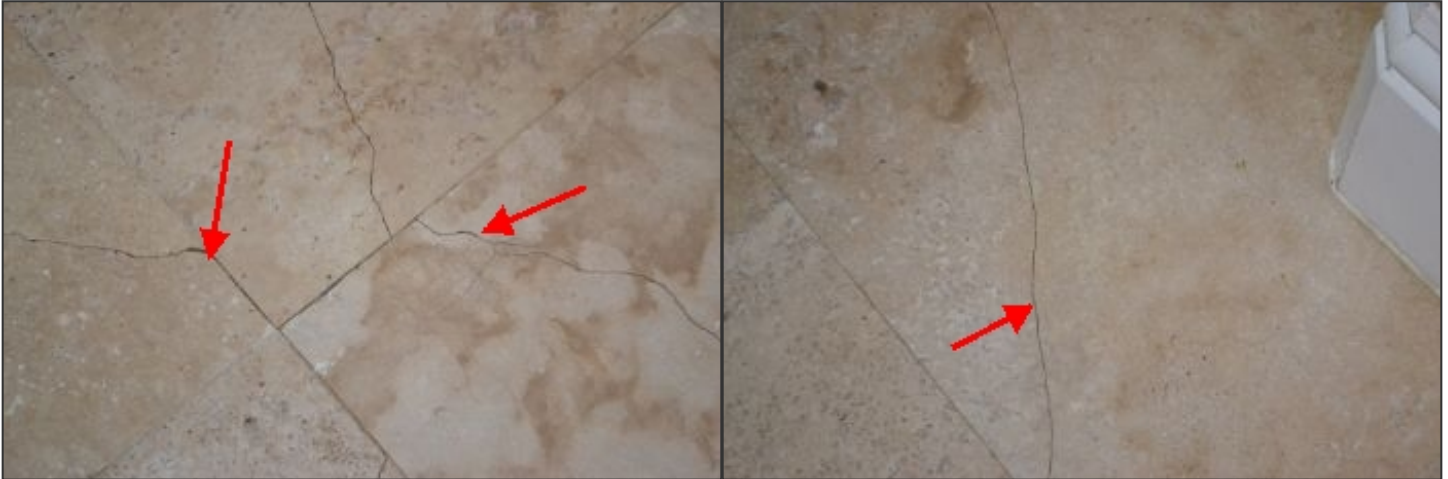
G.1. Cracked floor tiles visible throughout the home at the time of the inspection.

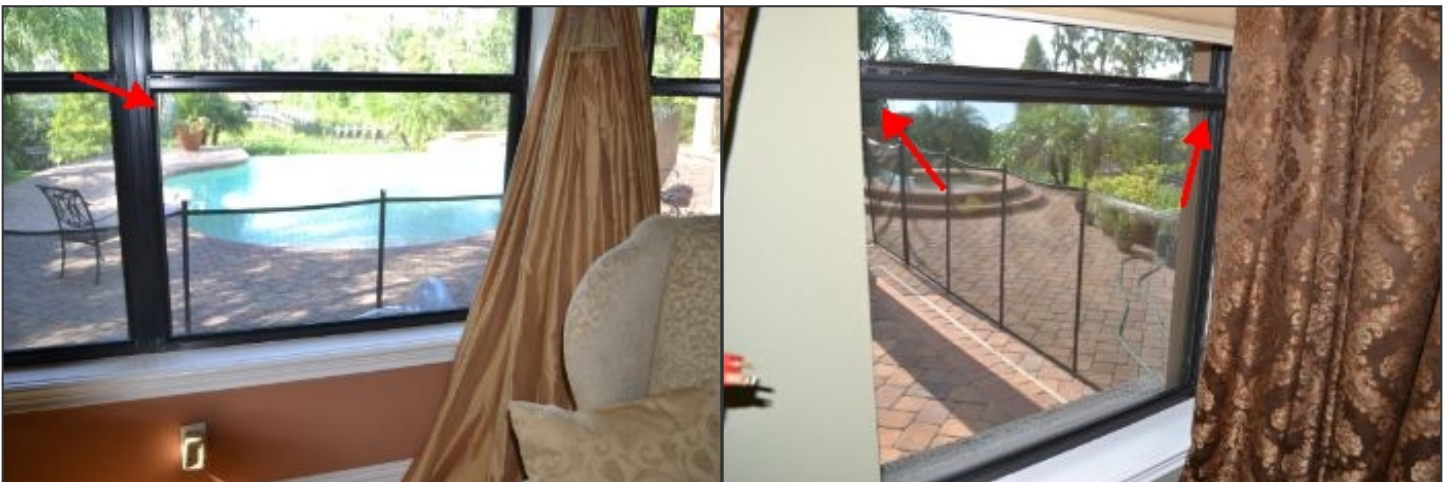
I.2. Some windows throughout the home did not stay in the up position and were difficult to operate. (see photos below for location)
