Your Property Inspection Report

Sample Report, Orlando, FL 32819
Inspection prepared for: Sample Report
Real Estate Agent: Jay Huberty - Regal Real Estate Professionals

Date of Inspection: 10/9/2012 Time: 2:00 PM
Age of Home: 5 years Size: 5,779 SF
Weather: Partly Cloudy

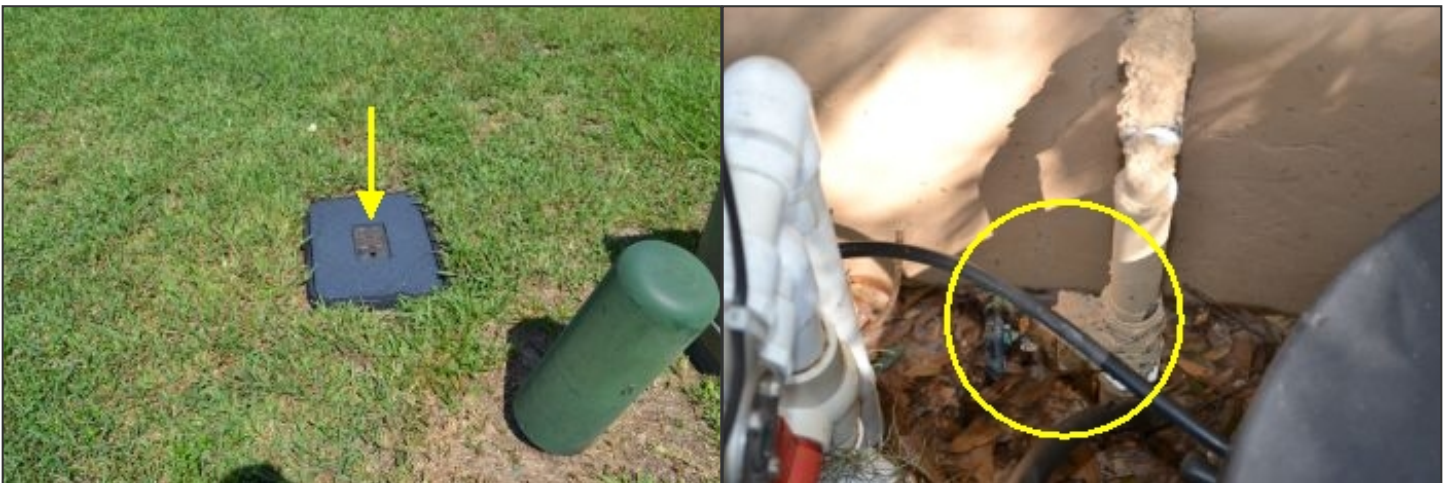
Water meter was located at the front yard of the home.

Main water shut off was located at the left side of the home exterior.

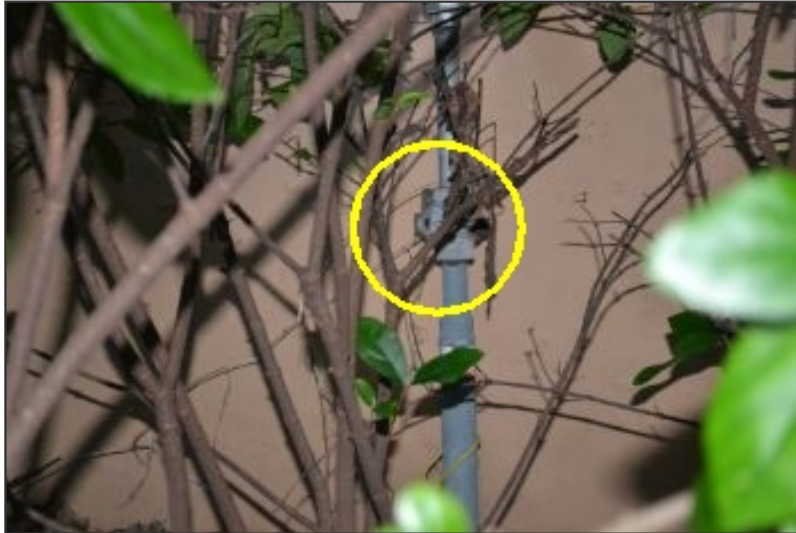
Main gas shut off valve was located at the right side of the home exterior

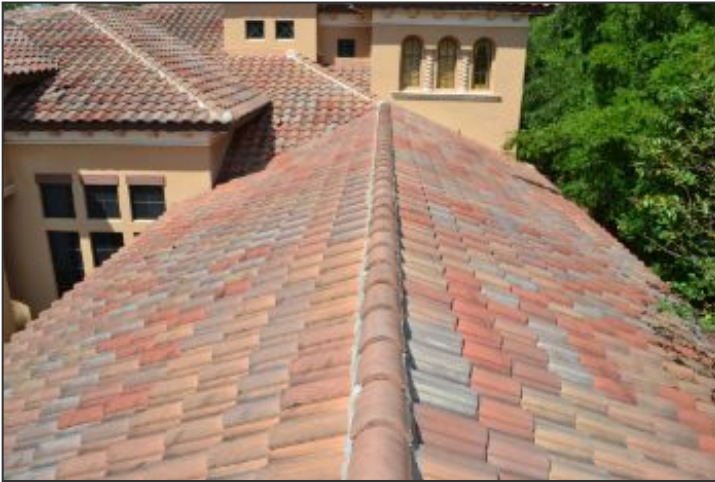
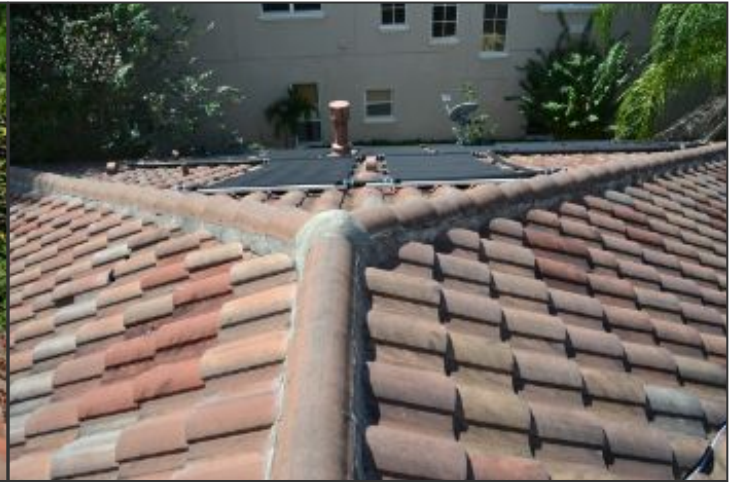
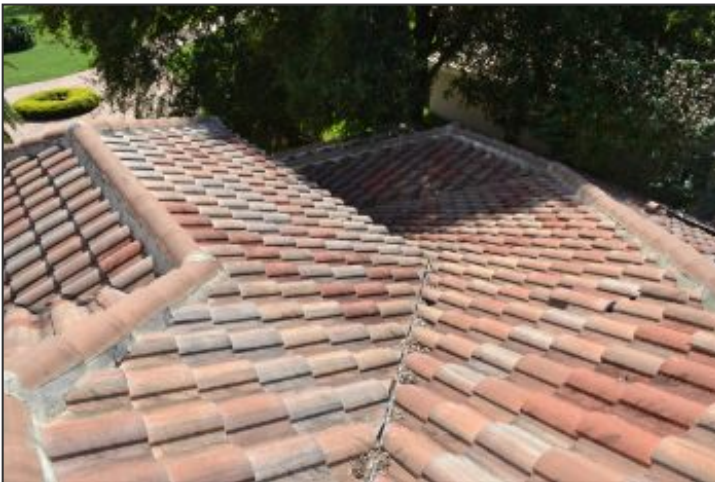
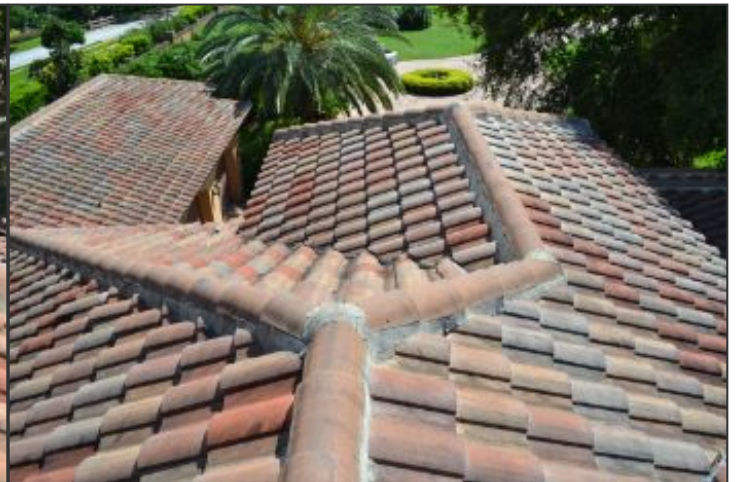
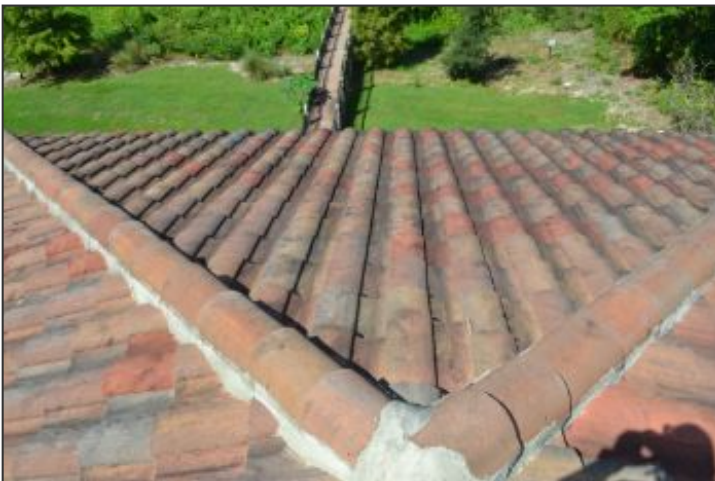
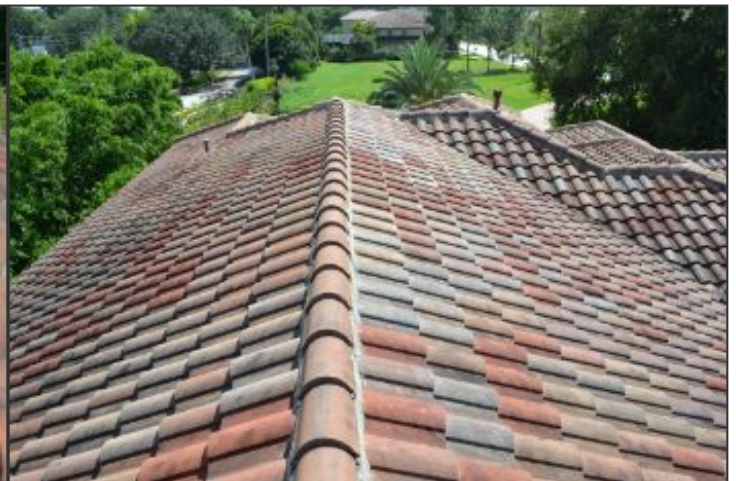
Roof Views

C.1. The roof had cracked or broken concrete roof tiles which should be replaced to prevent damage to the underlying roof structure from moisture intrusion.
